Manhole Inspection Summary

Manhole # S21CC1003MH

Insp Date: **3/13/07 2:00 PM**

Location Address: **2032 DRUID PARK DR**

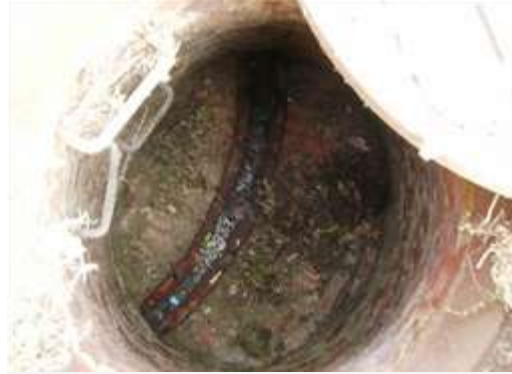
Top View

Evidence of surcharge - Bench debris.

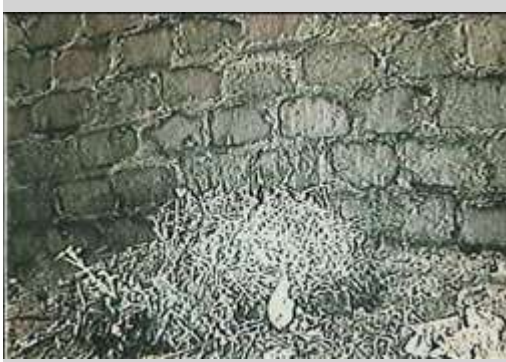
Defect

Barrel deterioration and infiltration. Bench debris.

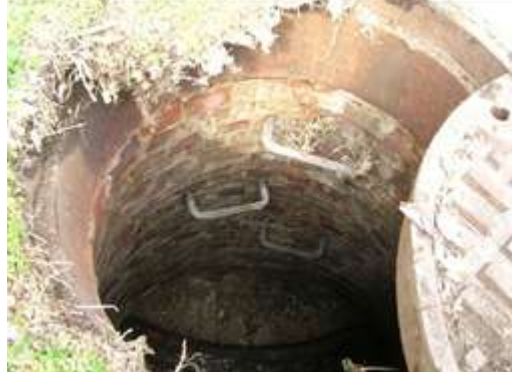
Defect

Frame leaks. Adjustment infiltration, root intrusion and infiltration.

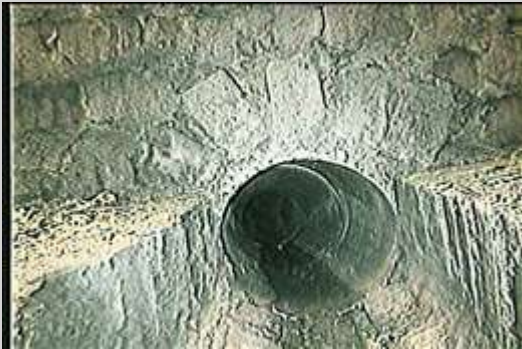
8 in. Circular Gravity Sewer Pipe Out @ 12 O'Clock

Deposits: ☐ None ☐ Mud ☐ Sludge ☐ Debris ☒ **Grease**

Silt Depth: **0** (in.) Deposits Extent: **Light**

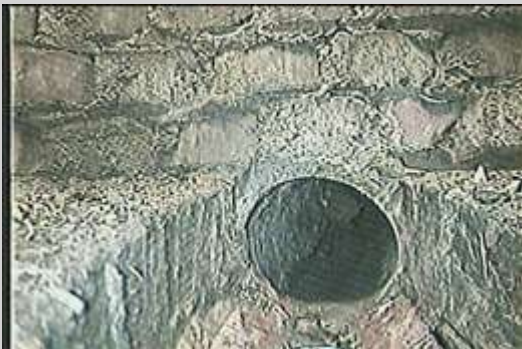
6 in. Circular Gravity Sewer Pipe In @ 7 O'Clock

Deposits: ☐ None ☐ Mud ☐ Sludge ☐ Debris ☒ **Grease**

Silt Depth: **0** (in.) Deposits Extent: **Light**
